Local site effects and incremental damage of buildings during the 2016 Central Italy earthquake sequence

ABSTRACT

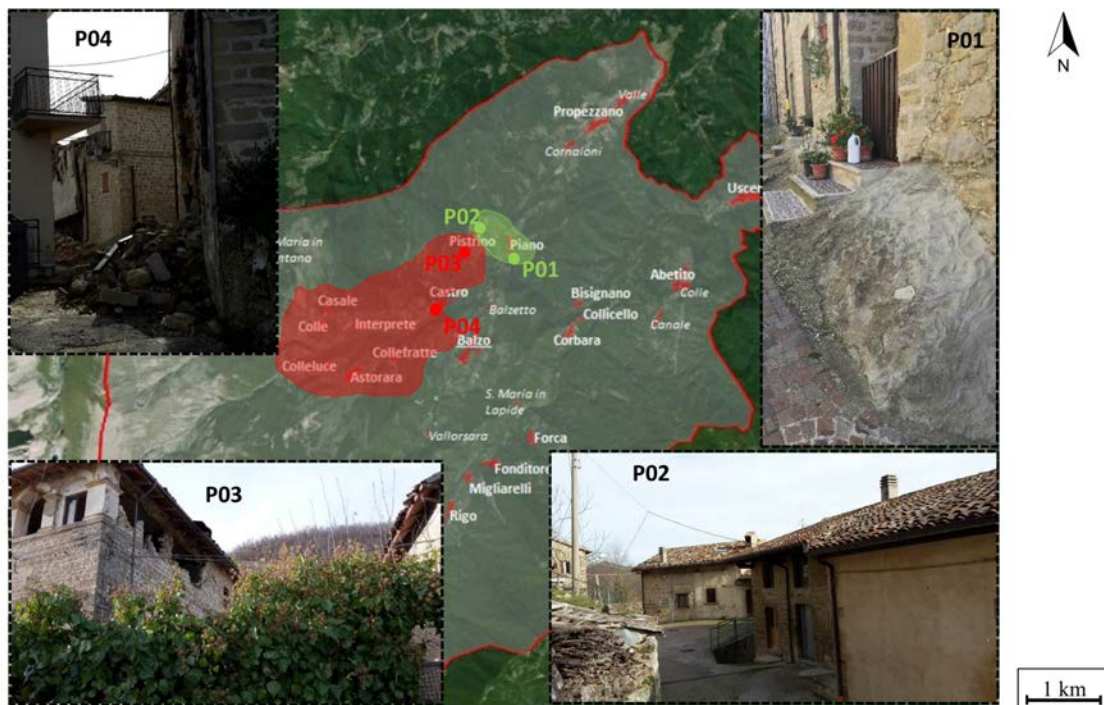
Other Montegallo's hamlets, such as Astorara, Castro, and Colleluce in the southwestern part of the area at a distance of 1.5 to 2.5km from Piano, located on quaternary deposits resting on rock, experienced high levels of damage and several cases of total collapse (D5). For example, Figure 3-P04 shows a street in Castro that was blocked by the debris of a damaged building. Given the proximity between Castro (highly damaged) and Piano (practically undamaged), and the very similar structural systems and construction standards, it is probable that Castro experienced stronger ground motions than Piano, due to significant topographic amplification. A view of the 3D model obtained with a drone survey over the entire area can also be found in BYU-PRISM (2016). It shows the typical crest configuration of the zone, leading to possible 2D topographical effects.

Figure 3. Spatial distribution of building damage across the municipality of Montegallo.

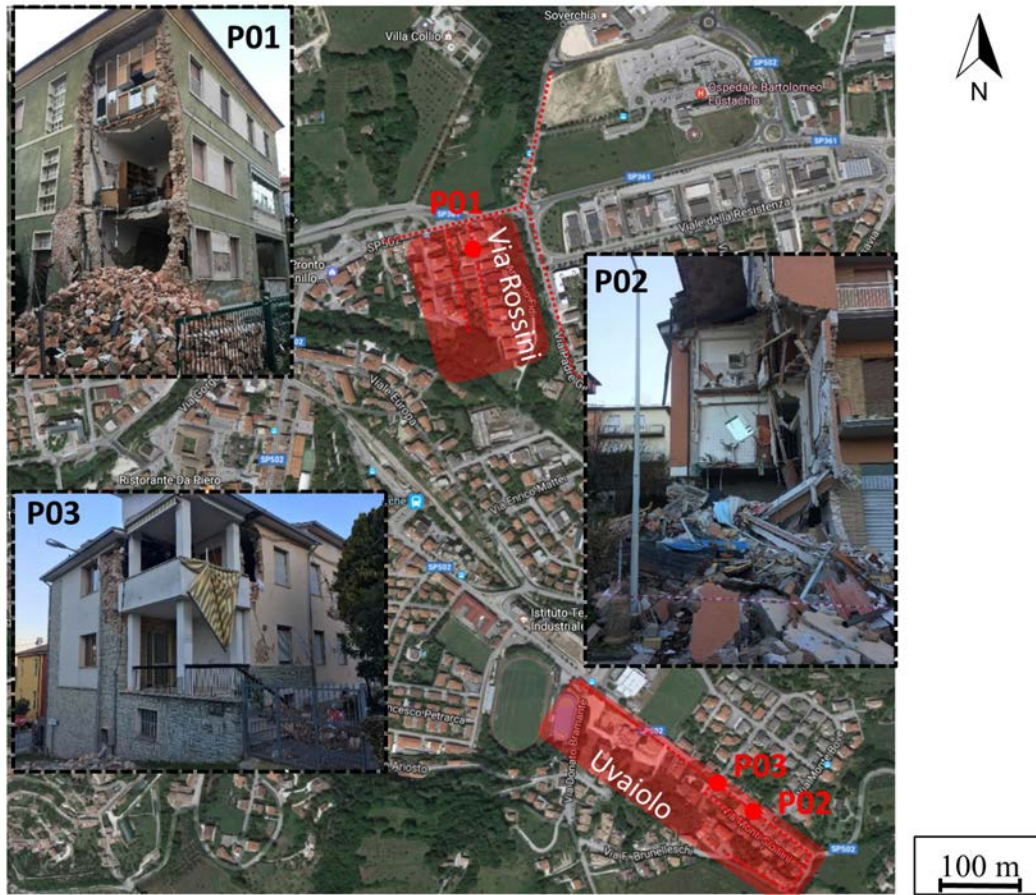
Other examples of local site effects were identified in some areas of San Severino Marche (number 11 in Figure 2). San Severino Marche is a town in the Province of Macerata, in the Marche region, located about 50 kilometers south-west of Ancona and about 25 kilometers south-west of Macerata. It has about 12,000 inhabitants, and it comprises more than 40 hamlets. Unlike Montegallo, San Severino has districts where most of the buildings are of reinforced concrete, built in the 1960s and the 1970s. Within San Severino Marche, two neighborhoods along Via Mazzini and Via Rossini attracted most of the GEER reconnaissance team attention due to the evident and quite localized damage observed (Figure 4). Via Mazzini is located uphill while buildings along Via Rossini are constructed on the ancient riverbed of the Potenza River. It is deemed that stratigraphic amplification is likely to have taken place due to the presence of soft shallow sediments resulted from the river artificial channeling operations. Similar damage patterns and site effects have been observed in Tolentino (number 10 in Figure 2), as described in GEER (2017).

Figure 4. Characteristic building damage within the town of San Severino Marche.

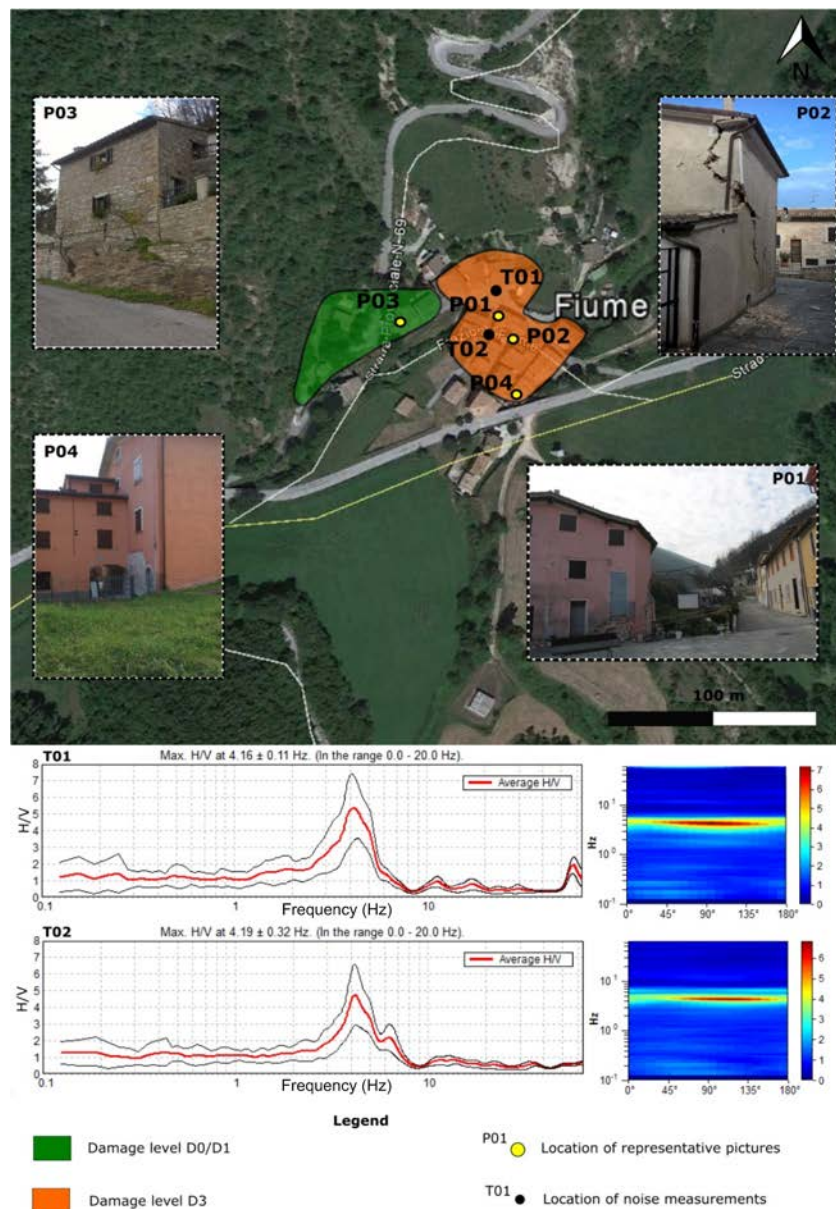
265 eastern part of the hamlet, founded on colluvial and alluvial deposits resting on bedrock,
266 suffered high levels of damage (D3) as shown in reference pictures P01-P02-P04, whereas
267 the western part, built on travertine rock, had only negligible damage (D0/D1, P03).

268 Two noise measurements (T01-T02 in Figure 5) were performed in the damaged zone
269 (east side of the hamlet) during the GEER mission. A portable Tromino tomograph was
270 employed and the total duration of each measurement was approximately 15 minutes.
271 Horizontal-to-Vertical (H/V) spectral ratios were computed by using the geometrical mean of
272 horizontal components. In addition, H/V ratios were computed by rotating the horizontal
273 component between 0° and 180° (directional or polar HVSR), in order to investigate
274 preferential directions of site amplification (i.e., the polarization of ground motion). Both
275 H/V and polar H/V are reported in Figure 5 showing a large H/V peak around 4 Hz, which
276 shows significant stiffness contrast between the upper soil layers and the underlying bedrock,
277 i.e. a typical proxy of local site amplification.

Figure 5. Damage zonation within the village of Fiume (up). Location and results of noise measurements in terms of H/V spectral ratio (bottom left) and polar plot (bottom right).

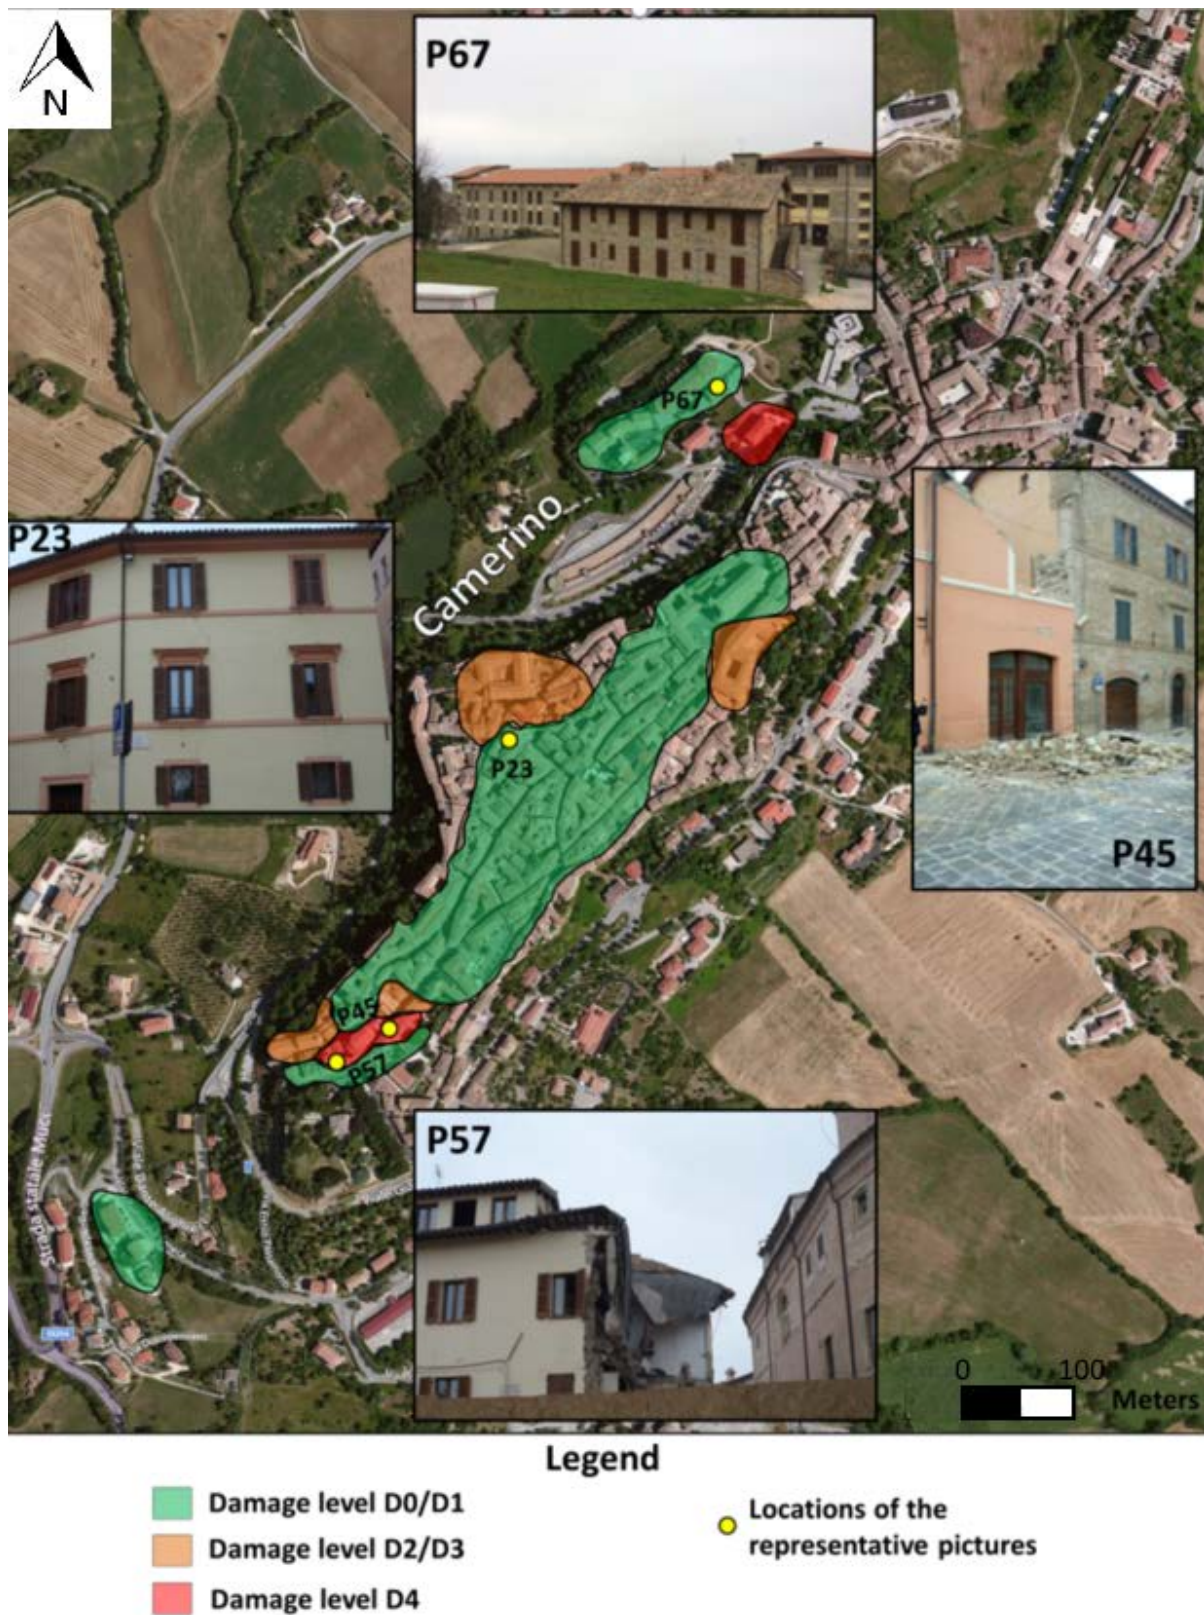
Figure 6 depicts the damage distribution across the main village, as inspected after the 30 October event. Relatively low damage (D0 or D1) were observed within the inner part of the ridge characterized by local bedrock (GRS) outcrops. Higher damage levels (D2-D3) were observed for many of the low rise (2-3 stories) unreinforced masonry buildings, even if some of them were partially retrofitted. The damage is mainly localized on the hillside, where potential topographic amplifications and permanent deformation (due to slope instability) may be occurred. The highest damage level (D4) was observed at the SW side of the historic center and at the bottom of the Camerino hill, where several masonry structures collapsed. The observed damage distribution pattern in Camerino is consistent with site effects that could be inferred from the geological map shown in Figure S5. Strong amplification of earthquake ground motions is highly probable given the thin soft layers of eluvio-colluvial soils (ML) overlying the bedrock.

Figure 6. Damage zonation within the historic center of Camerino with pictures of the representative structures inspected.

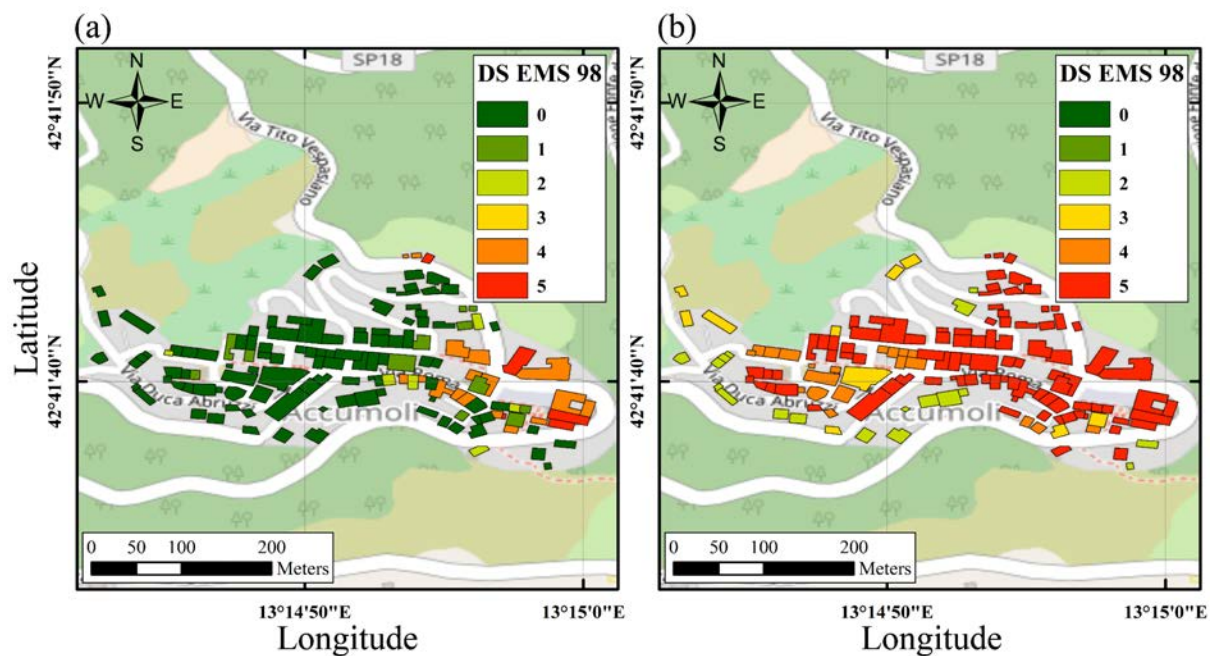
Figure 7 illustrates the structural damage levels observed during the two surveys, after the 24 August (left) and the October events (right). After the August 24th event, the most severe damage was observed at the eastern side of the village, while the vast majority of the building stock retained its structural integrity null or with minor damage (D0-D1). However, at the end of the seismic sequence, Accumoli was almost completely destroyed. Few buildings, in the south end of the village survived the sequence of events with limited damage (D2).

Figure 7. Damage levels in the main village of Accumoli (a) after the first earthquake and (b) at the end of the entire sequence.

The evolution of structural damage **during the earthquake sequence** is clearly reflected in the observed damage: 72% of the buildings experienced zero (DS0) and 8% minor damage (DS1) after the first earthquake, while not a single building was found intact or with minor damage after the seismic sequence. Large damage states were in contrast more populated (4% to 13% for DS2, 0% to 7% for DS3, 12% to 14% for DS4, and a major shift from 4% to 65% for DS5).

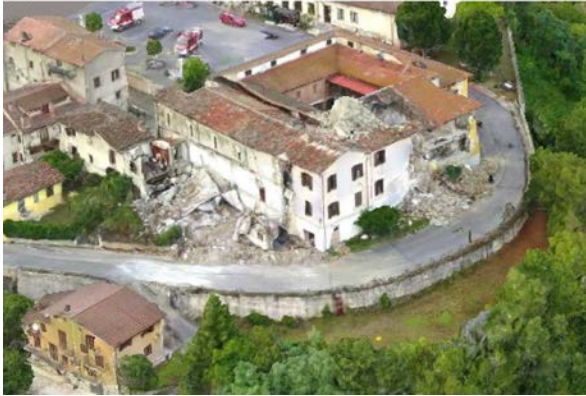
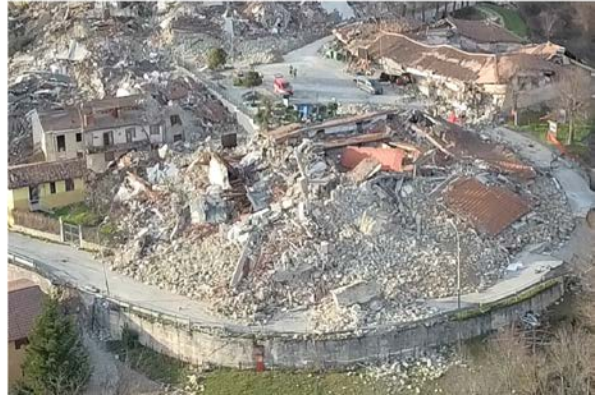
Figures 8a and 8b show an aerial view of the east part of the village during the first and the second surveys, respectively, including the local church and the police station, which eventually collapsed because of multiple earthquake excitations. **Figures 9, 10 and 11** illustrate characteristic cases of minor-to-moderate shear and out-of-plane damage after the August event that **led** to abrupt collapse because of the earthquake sequence. Age of construction, high spectral accelerations for periods lower than 0.3s (which match the natural periods of low-rise buildings) and the variation of spectral polarization across several events were likely the main contributors to the observed catastrophic damage patterns. Given the location of Accumoli, topographic effects may also have contributed to the observed damage.

Figure 8. Aerial photos of the east side of Accumoli after (a) the first earthquake and (b) the entire earthquake sequence.

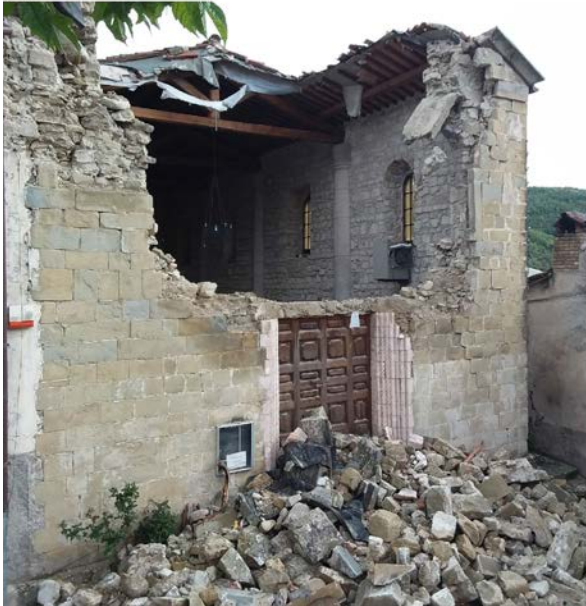
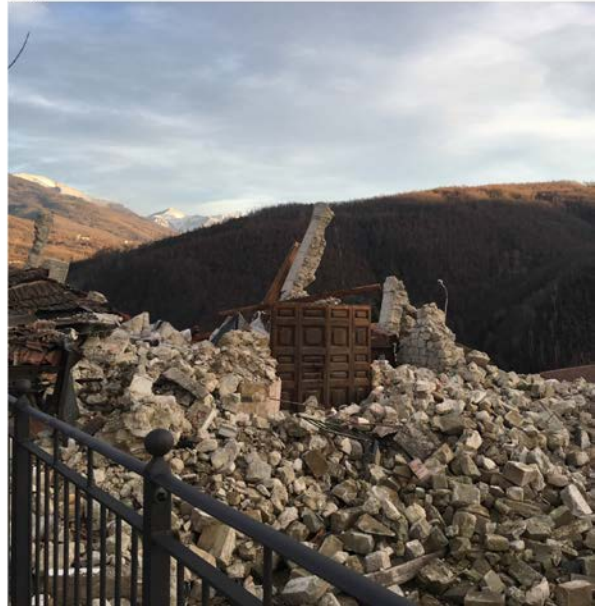
Figure 9. The local church: (a) after the first earthquake; and (b) after the entire sequence.

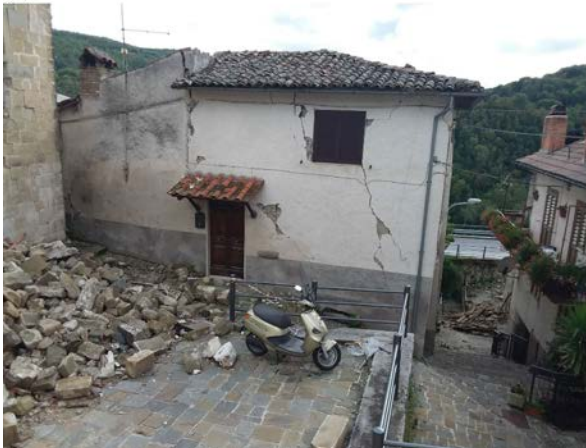
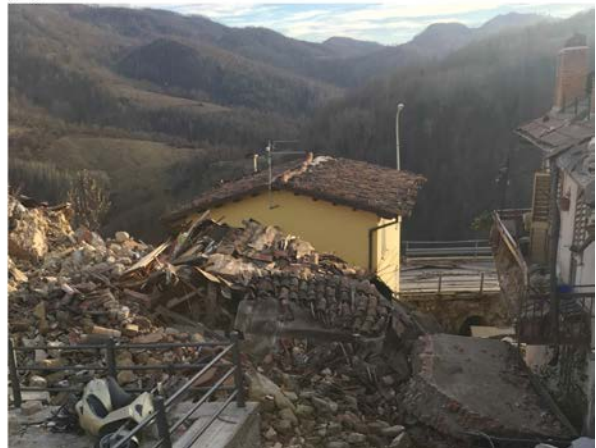
Figure 10. Masonry residential building: (a) after the first earthquake; and (b) after the sequence.

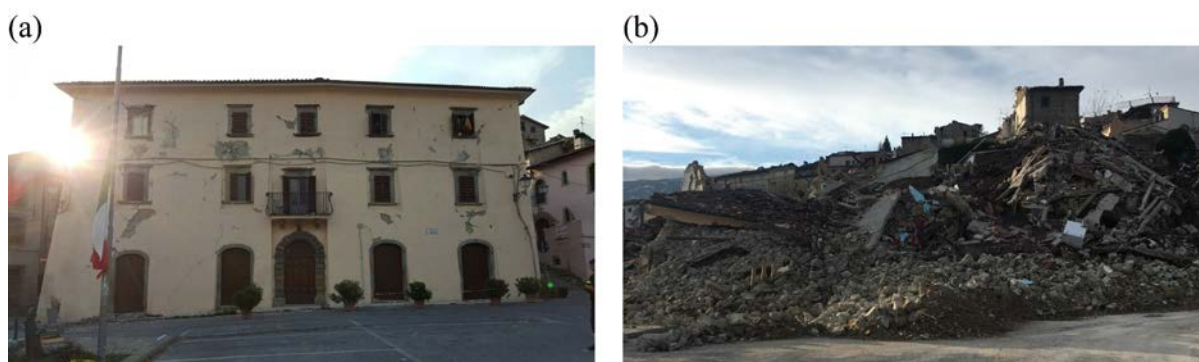
Figure 11. The town hall: (a) after the first earthquake; and (b) after the entire sequence.

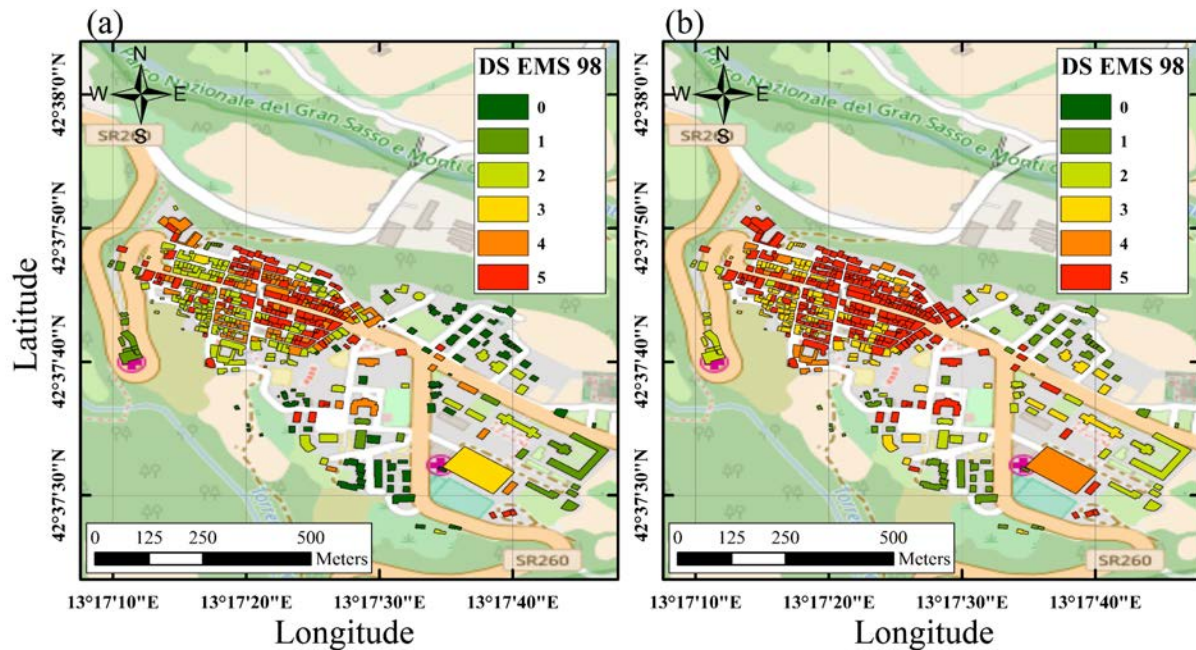
Figure 12 shows the structural damage levels observed during the two surveys. The 24 August event caused severe damage to the south-east part of the historical city center along the main avenue (Corso Umberto I). As observed in the case of Accumoli, many buildings that were still standing after the first event with only a small residual capacity to additional horizontal actions, fully collapsed because of the subsequent September and October events. The **shifting** of damage states between the aftermath of the first event and the end of the

entire sequence is reflected in the following inspection results clearly indicating a major shift to most critical damage states: intact buildings (D0) were reduced from 30% to 18%, buildings with minor damage (D1) were increased from 5% to 10%, moderate damage (D2) was reduced from 24% to 6%, D3 increased from 1% to 21%, D4 decreased from 17% to 3%, and collapsed buildings (D5) had a significant increase from 23% to 42%.

Figure 12. Damage levels observed in the center of Amatrice (a) after the 24 August earthquake (during the first survey), and (b) after the entire sequence (during the second survey).

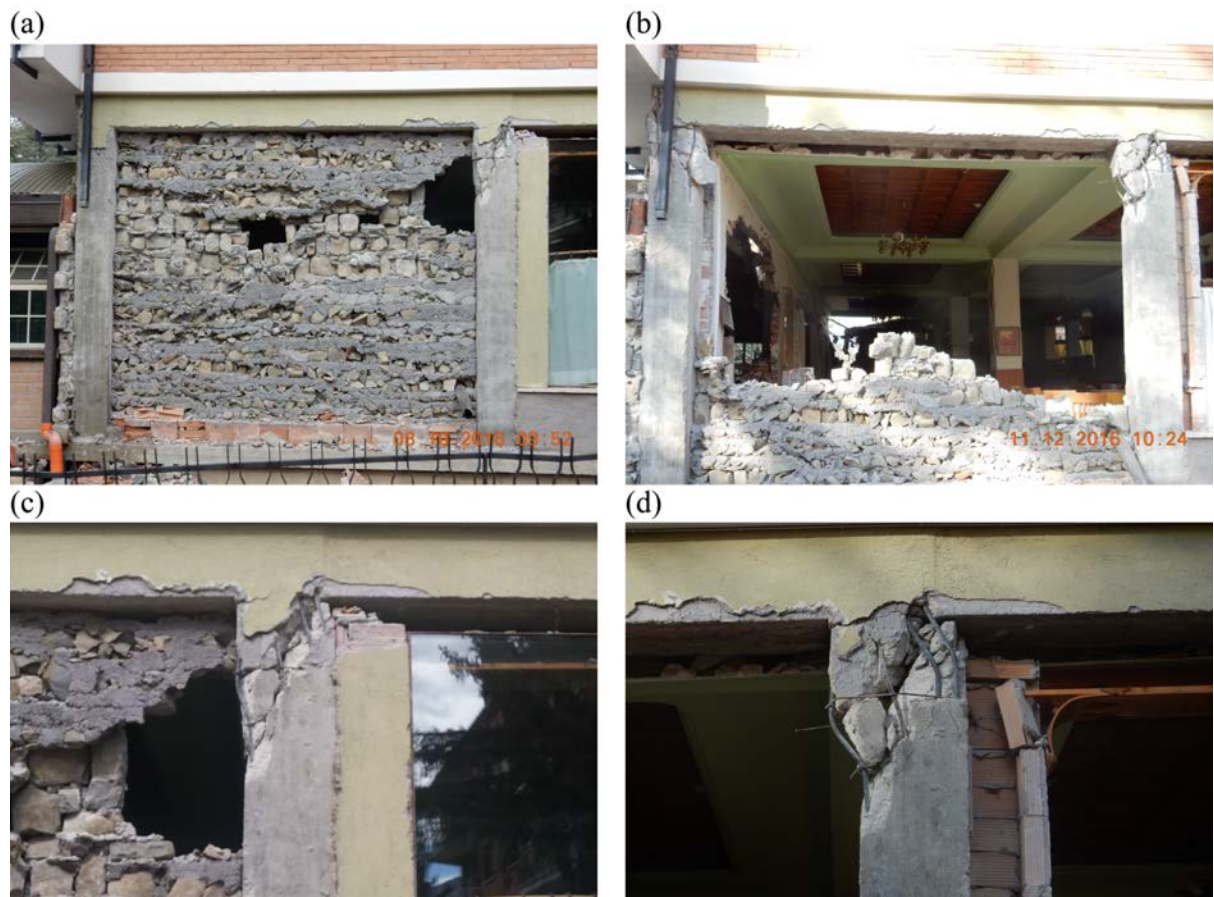
Figure 13. Reinforced concrete residential building (a,c) after the 24 August earthquake and (b,d) after the entire sequence. (a,b) External infill failure and (c,d) shear failure at the column top.

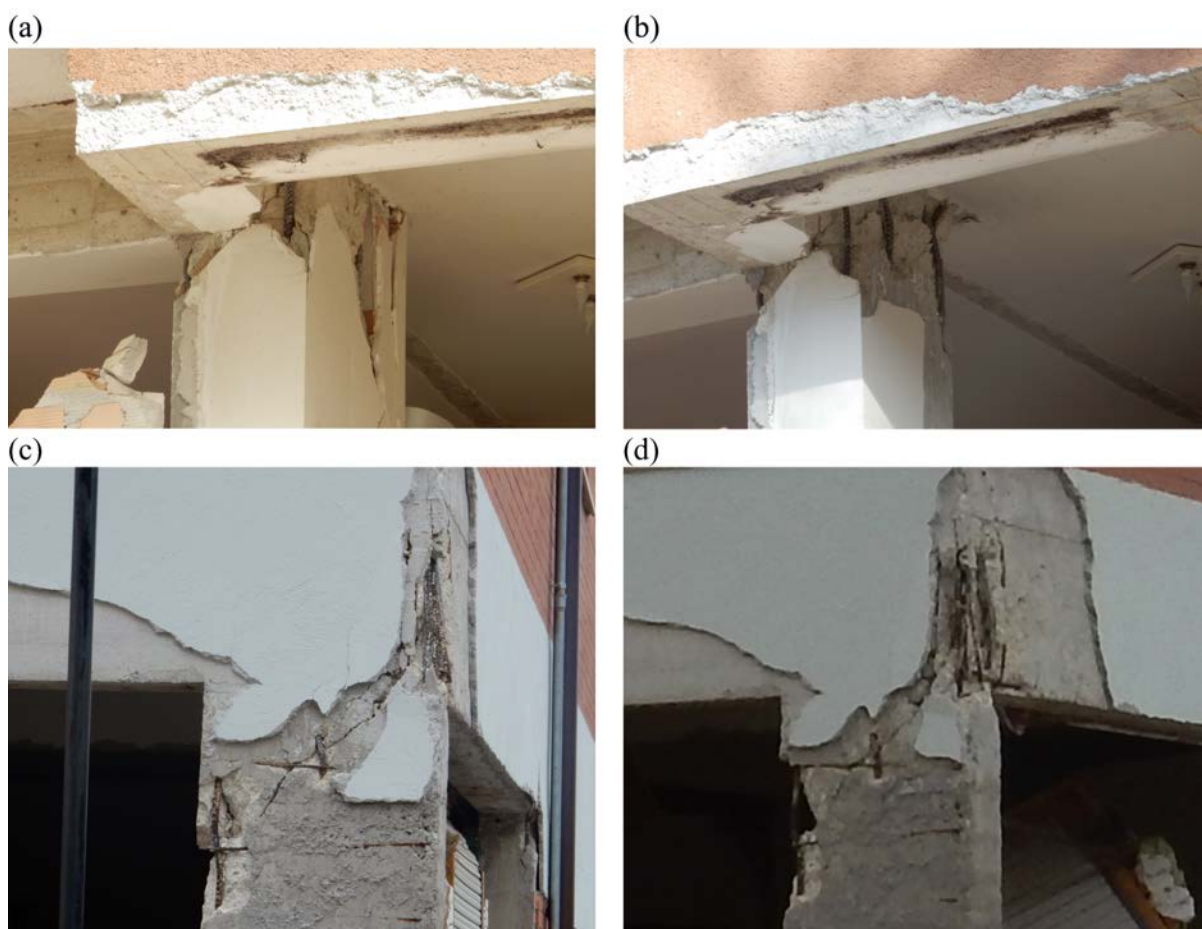
Figure 14. Beam-column joints. Concrete spalling and local bar buckling due to lack of transversal reinforcement after the 24 August event (a,c) and after the earthquake sequence (b,d).

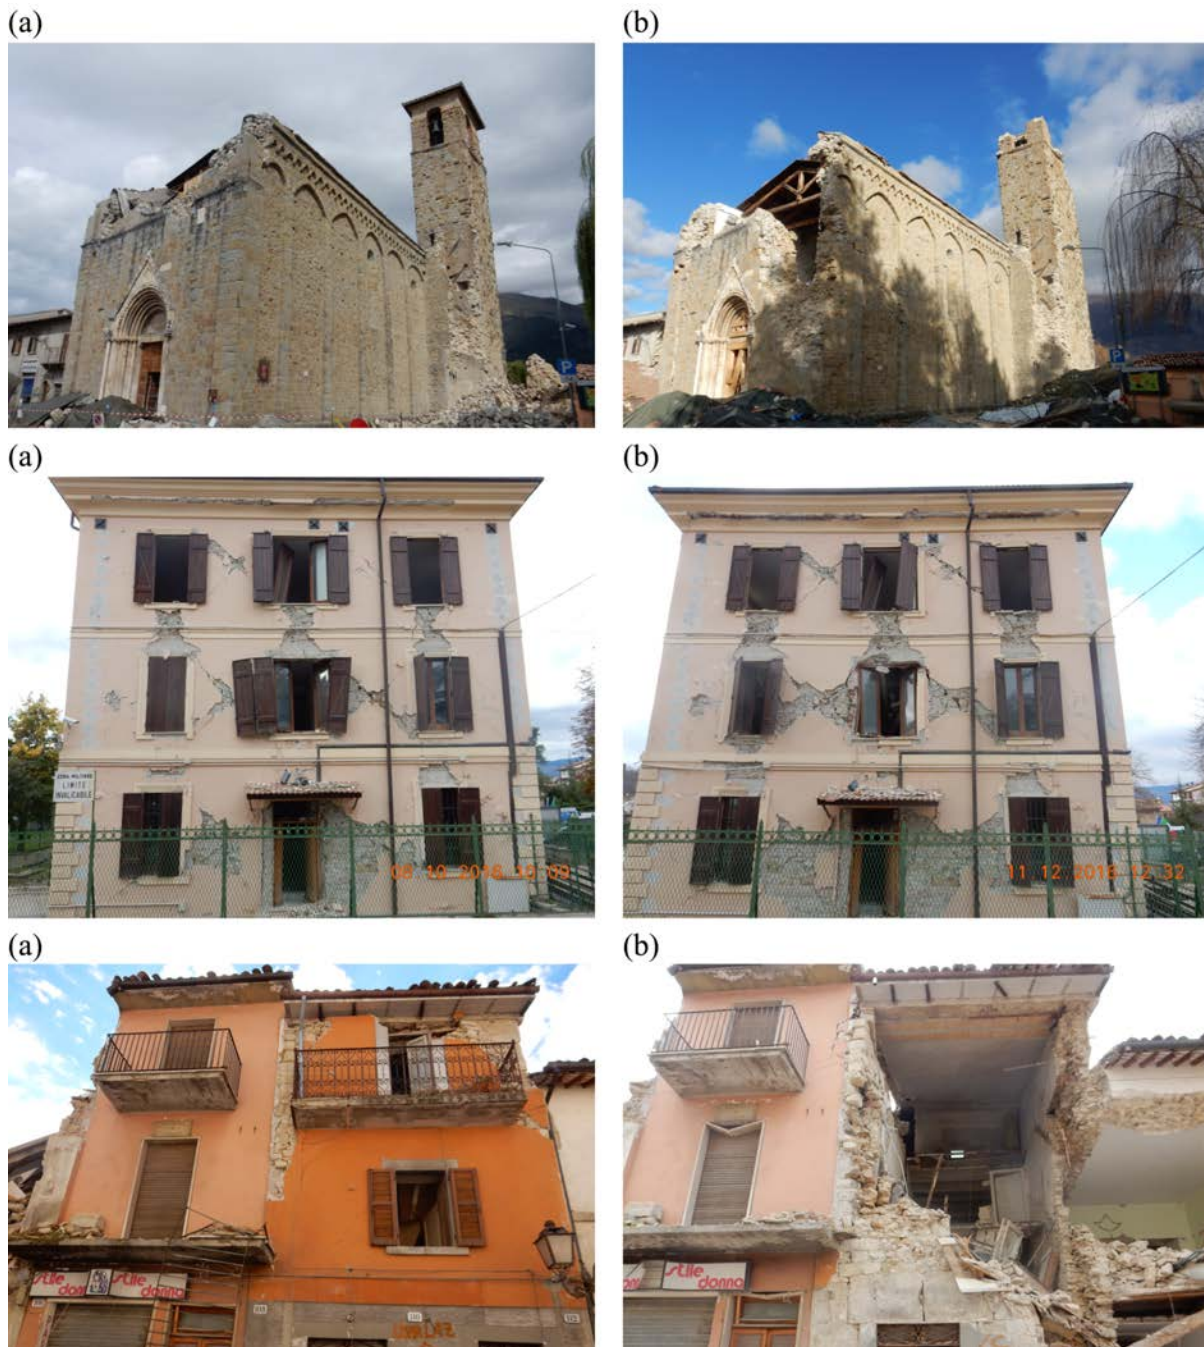
471 also clearly seen in several characteristic masonry structures, such as the church of
472 Sant’Agostino (Figure 17, top), the local police (“Carabinieri”) station (Fig. 17, middle) and
473 typical residential buildings (Fig. 17 bottom and Fig. 18).

475 **Figure 17.** Incremental structural damage of the church of Sant’Agostino (top), the local police
476 station (middle) and one of the several masonry buildings collapsed after (a) the event of 24 August
477 earthquake and (b) the entire sequence.

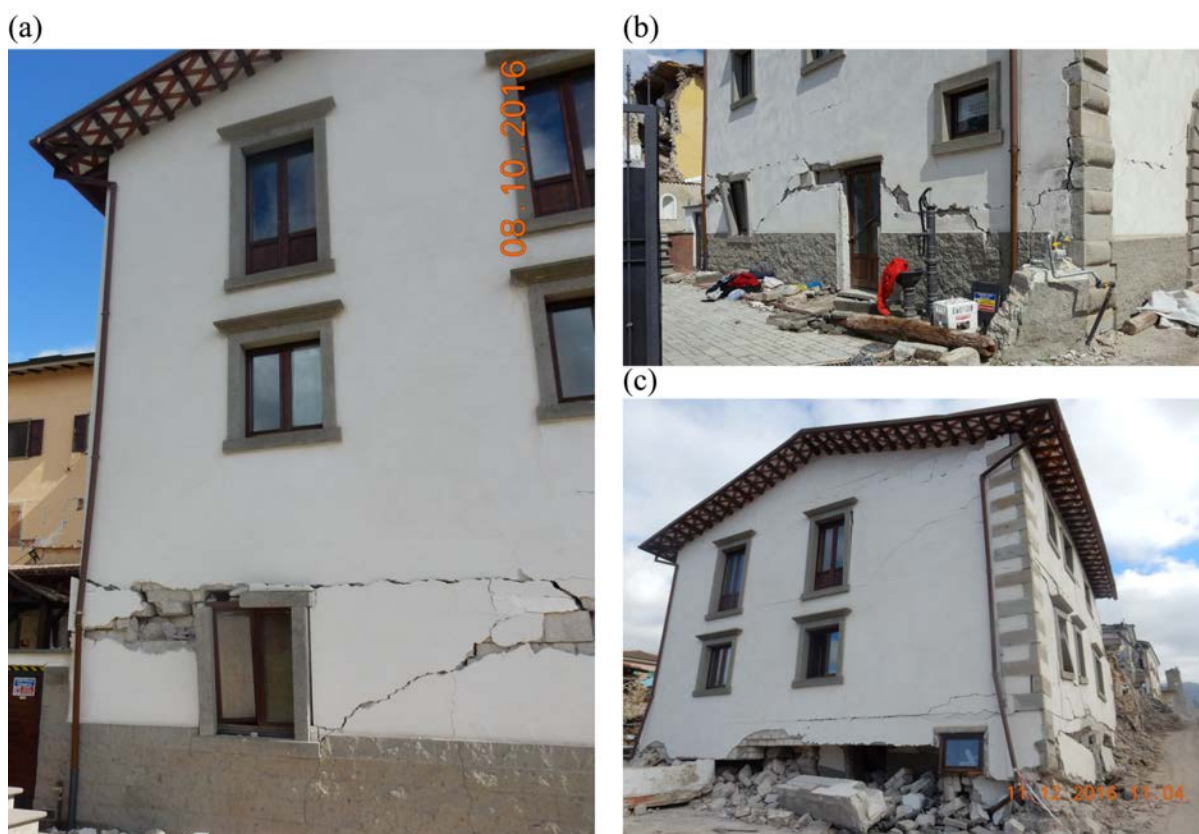
Figure 18. Residential masonry residential building after the 24 August earthquake (a, b) and (c) after the entire sequence. Shear failure of the ground floor bearing wall leads to soft story collapse at the end of the third event.

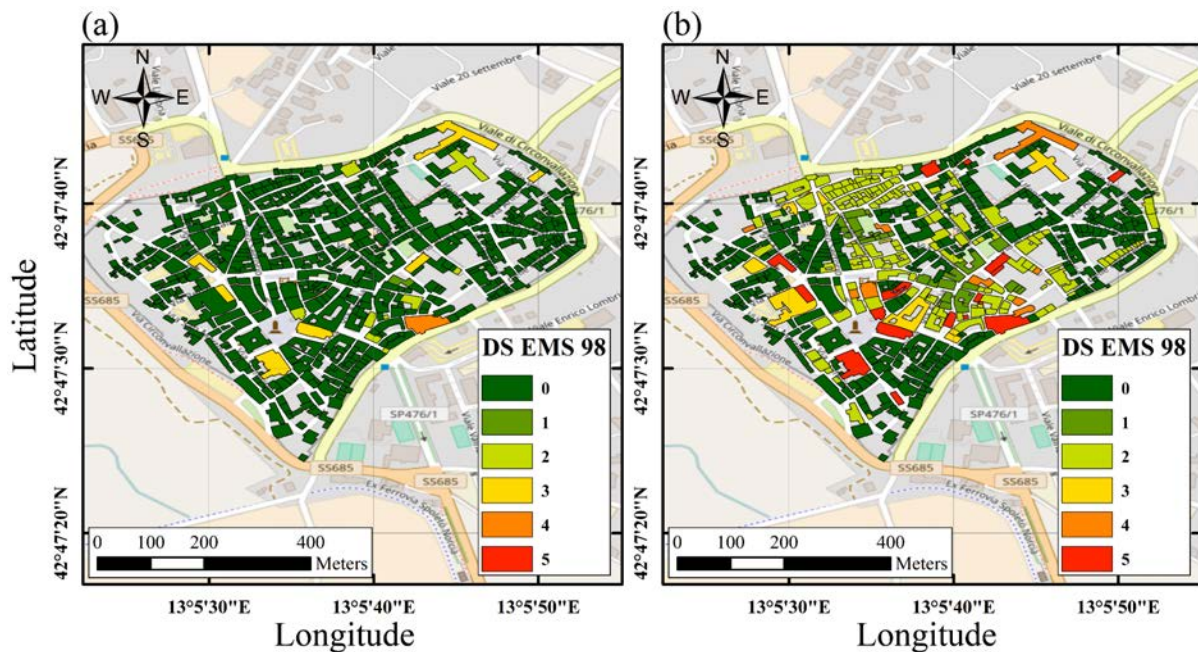
514 Figure 19 shows the structural damage levels observed during the two inspection
515 campaigns. Following the 24 August earthquake, only a small number of buildings
516 experienced medium or severe damage, located mainly in the historical center of the town.
517 This good performance can be primarily attributed to two reasons. First, after the 1859
518 earthquake, the reconstruction of Norcia was based on a set of new practical rules of thumb
519 prescribing a minimum wall thickness, the use of buttresses, the reduction of building height,
520 the use of vaults only at ground floor and the mandatory presence of good wall-to-wall
521 connections. The increased wall thickness is still visible in many structures, and in several
522 buildings, the wall thickness varies linearly along the height of the first story. Secondly, a
523 series of repair and strengthening works followed the 1997 Umbria-Marche event, **which**

524 **improved** the capacity of sub-standard buildings. Such retrofits are generally not visible from
525 outside, but confining ring-beams and cross-ties can be traced externally in many cases.
526 Despite the **adequate** structural response of the buildings in Norcia during the 24 August
527 event, a sharp increase of damage, yet not as disproportional as in the case of Amatrice, was

observed at the end of the seismic sequence, mainly in heritage construction such as churches and monasteries. The following variation of cumulative damage was reflected in the statistical distribution of the different damage states: intact buildings (DS0) were reduced from 97% after the first earthquake to 67%, which was a substantial change in structural behavior. Minor damage (DS1) also increased at the end of the entire sequence to 4% from almost 0% after the first event. The same applies to moderate damage (DS2), it increased from 1% to 24%, previously, and to DS5 increased from 0% to 3% in the first event, DS3 and DS4 remaining practically constant.

Figure 19. Damage distribution in the historical center of Norcia (a) after the 24 August event and (b) at the end of the entire seismic sequence.

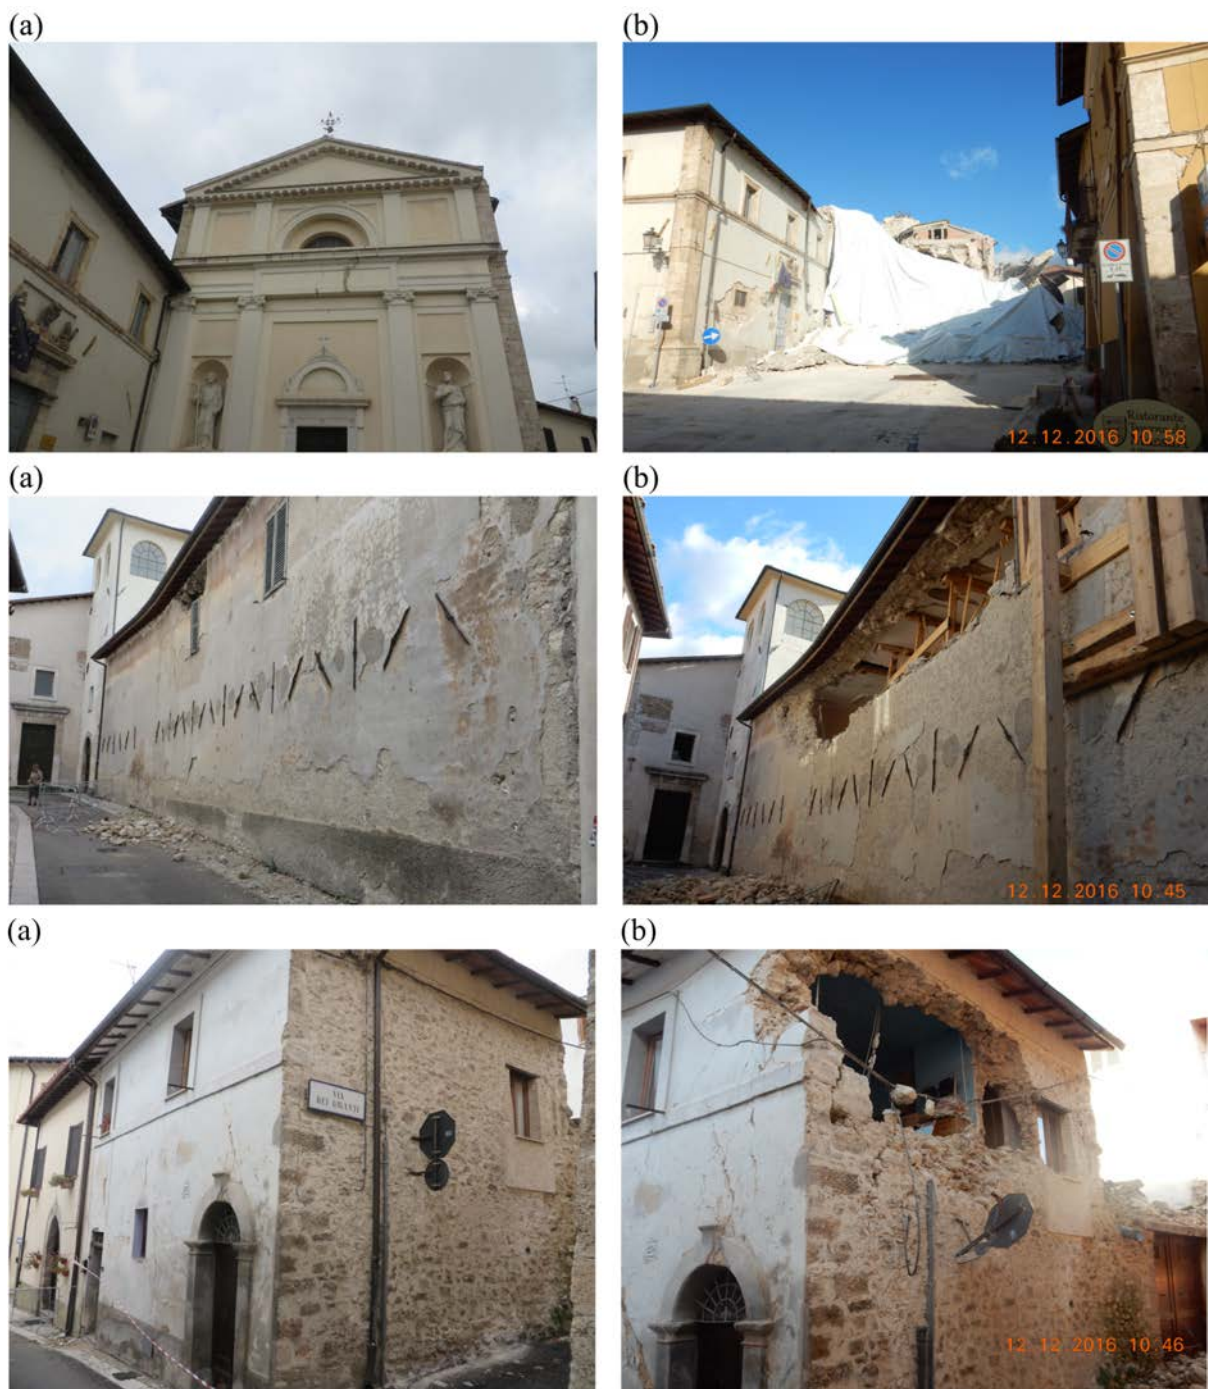
Figure 20 (top) shows one of the churches that was slightly damaged by the **M6.1** 24 August seismic event but collapsed following the **M6.5** 30 October event. Many historical churches in Norcia experienced similar damage evolution, as shown for instance in Figure 20 (middle), where the out-of-plane failure of a historic monastery and the partial loss of support of the roof is depicted. Notably, the wall failure was concentrated at a level higher to that of the seismic retrofit, thus highlighting that the retrofit shall not be only localized on the ground level but also take into consideration the reduced axial load and weak diaphragm action of the masonry walls at the higher level. Figure 20 (bottom) shows two masonry residential buildings with irregular masonry construction that experienced only minor cracking during the first earthquake, but significant out-of-plane and in-plane wall failure under subsequent events.

Figure 20. Seismic damage observed in characteristic masonry buildings (a) after the 24 August earthquake and (b) at the end of the entire seismic sequence.

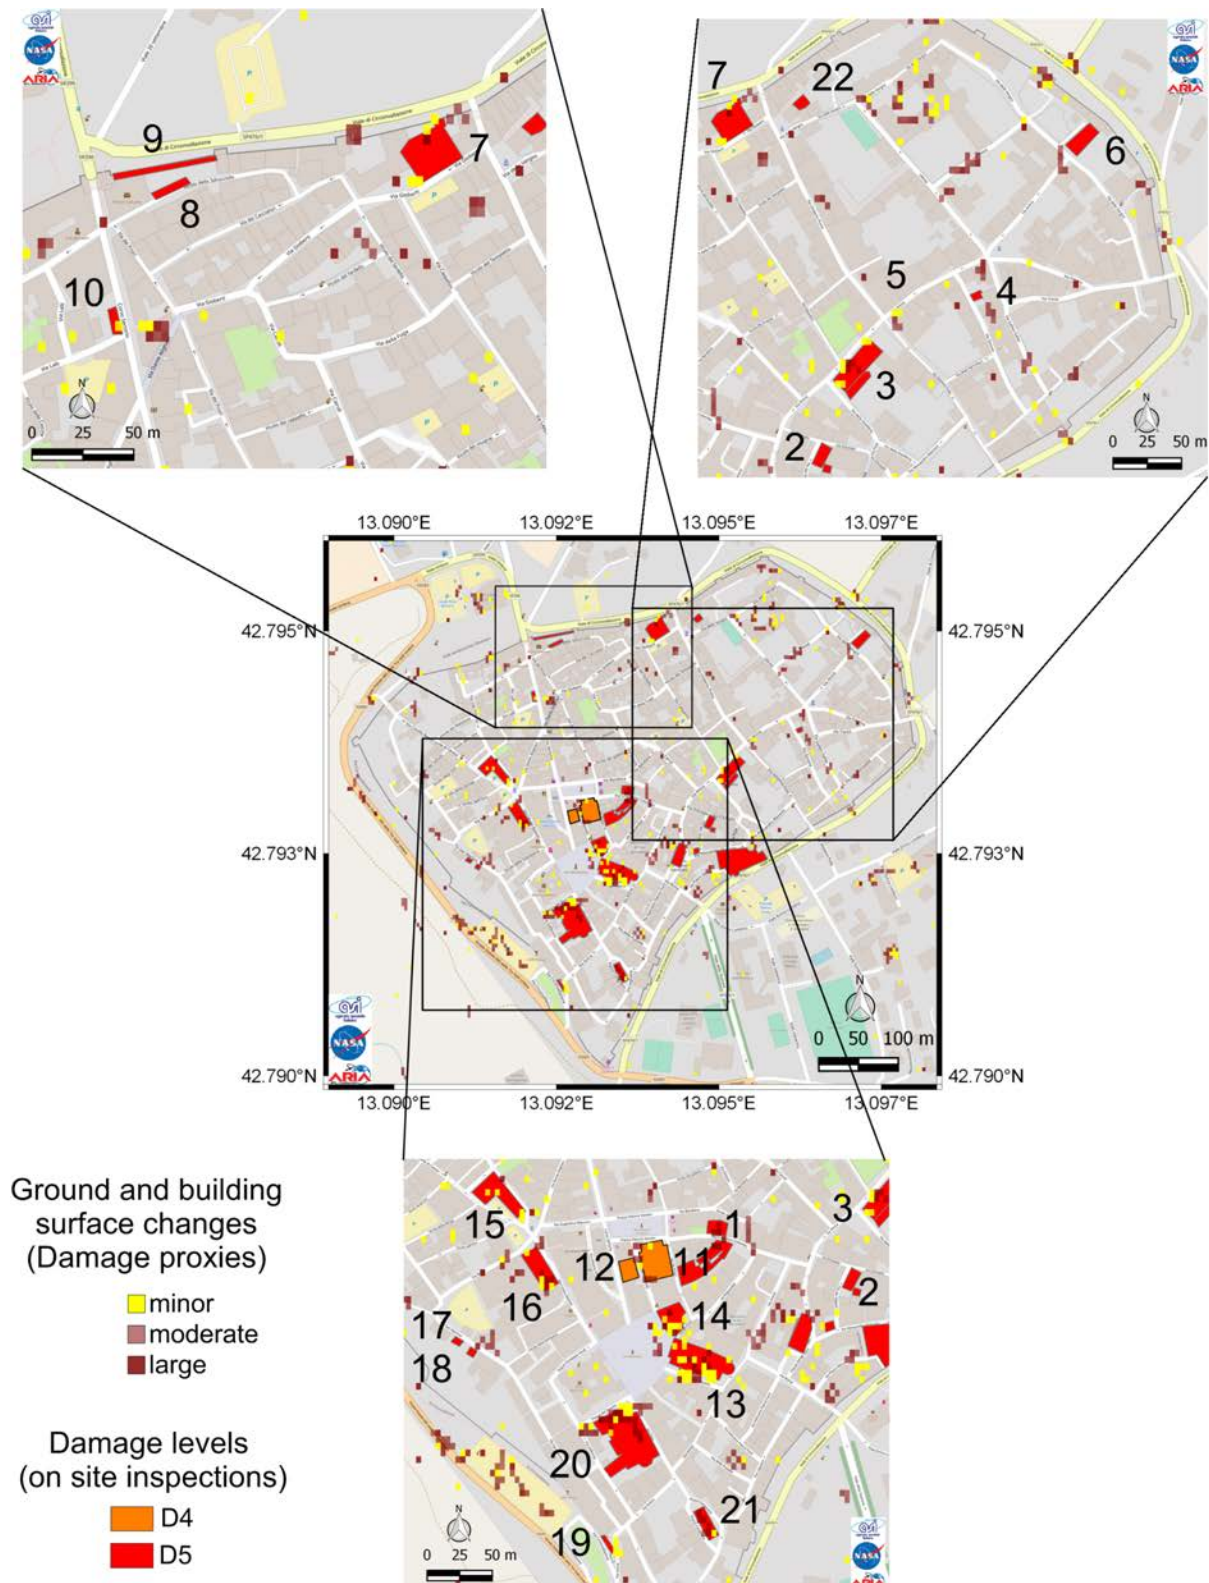
Figure 21 shows the DPM produced for the historical center of Norcia after the **M**6.5 30 October event, that is, the end of the earthquake sequence, superimposed with 22 structures that were classified visually as completely collapsed (D5), and selected D4 structures.

By comparing the locations of these mapped structures and the damage zones from ARIA imaging, a good agreement was observed. In particular, for all structures with an assigned damage level of collapse (D5), the DPM accurately showed a concentration of red and dark red zones, representing areas in which substantial deformations occurred.

Figure 21. Damage proxy map of Norcia, along with the identification numbers of all structures with assigned damage level D5 and selected structures with assigned damage level D4, from field inspections and available high-quality on-site information and photos.
